18000 Pump Series Technical Guide

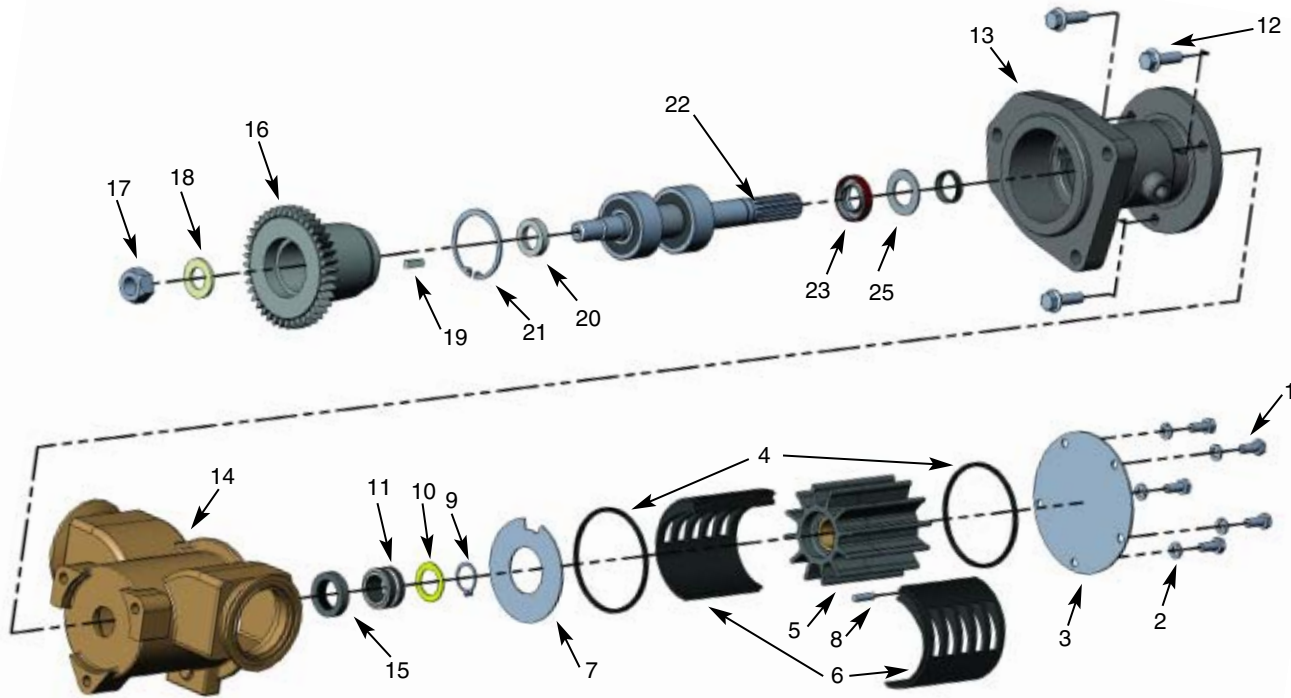
Assembly / Disassembly Instructions

The following assembly/disassembly procedures apply to all 18000 Series pumps. Deviations from pump to pump are primarily a result of different methods of drive and mounting. Pump numbers can be found stamped into the cover plate of the pump.

- A. Remove the bolts (1) and lockwashers (2) from the cover (3).
- B. Remove the cover, quad rings (4), impeller (5), cam liner halves (6), and wearplate (7). Note the direction of the impeller blades to ensure proper replacement of the impeller during the assembly procedure. Caution: the pin (8) might fall out from its place between the cam liner halves.

- C. Using external snap ring pliers, remove the retaining ring (9) from the shaft.
- D. Slide the washer (10) and mechanical seal (11) off of the shaft.

- E. Remove the bolts (12) holding the body (13) to the housing (14).
- F. Slide the housing off of the shaft and body assembly.
- G. Press the seal seat (15) out of the housing.

- H. When applicable remove the drive gear assembly: while supporting the drive gear (16), remove the nut (17), nut washer (18), and key (19) from the shaft. Slide the gear off of the shaft and remove the thrust washer (20) behind the gear.

- I. Using internal snap ring pliers, remove the retaining ring (21) from the body. Remove the bearing shield (24) from the body.
- J. Press the bearing and shaft assembly (22) out of the body.

- K. Remove the lip seal (23) and washer (25) from the body.
- L. Inspect the shaft for grooving of the lip seal area and heavy fretting of the spline portion that drives the impeller. Inspect the bearings for loss of grease, corrosion, and rough rotation. If the shaft or bearings exhibit such a wear, replace the entire shaft and bearing assembly (22) listed on page 3.

- A. Replace the washer (25) then press the lip seal (23) into the pump body (13) with the metal backing ring of the lip seal toward the housing (14) and away from the engine. Care should be taken to insure proper alignment of the lip seal to the pump body and that the lip seal is uniformly pressed to prevent distortion.
- B. Press the shaft and bearing assembly (22) into the pump body.
- C. Slide the bearing shield (24) into the pump body and against the inner bearing.
- D. Using internal snap ring pliers, install the retaining ring (21) into the body.

- E. Press the mechanical seal seat (15) into the housing with the white ceramic seal face or gray silicon carbide face toward the impeller. Lubricate the outside of the seat boot with a water soluble lubricant or soapy water for easier assembly. Oil or grease must not be used as it will prevent the rubber cup assembly from properly gripping the housing. The seat should be inspected to ensure that the cup did not become partially dislodged during the assembly procedure.

- F. Slide the housing over the shaft and body assembly. Apply Loctite #262 or equivalent to the bolt threads. Fasten the three bolts (12) and torque them to 25 ft-lbs.

- G. When applicable, replace the drive gear assembly. Slide the thrust washer (20) onto the outer bearing. Place the key (19) in the shaft, then slide the gear (16) on the shaft. Apply Loctite #262 or equivalent to the shaft threads. Replace the washer (18), then tighten the nut (17) onto the shaft for the G1808, G18081-01, G18082-01 and G18082X. While supporting the drive gear, torque the nut to 270 ft-lbs. For all other models, refer to applicable engine manufacturer's torque requirements. * 24007 contains 2 thrust washers. The G18082-01 utilizes the 23926 washer, which is .300" thick and 1.38" diameter of solid steel. The G1808 and G18081-01 use the 22779 washer, which is dimensionally the same, except it has a step in the internal diameter.

- H. Lubricate the inter rubber portion of the mechanical seal (11) with a water soluble lubricant or soapy water and slide the seal onto the shaft, with the carbon or silicon carbide portion of the mechanical seal toward the seal seat. Oil or grease must not be used as it will prevent the mechanical seal from properly gripping the shaft.

- I. Place the washer (10) onto the shaft and against the mechanical seal (see below to identify the proper washer) and then using external snap ring pliers, install the retaining ring (9) into the groove in the shaft to compress the mechanical seal.
