18000 Pump Series Technical Guide

Assembly / Disassembly Instructions

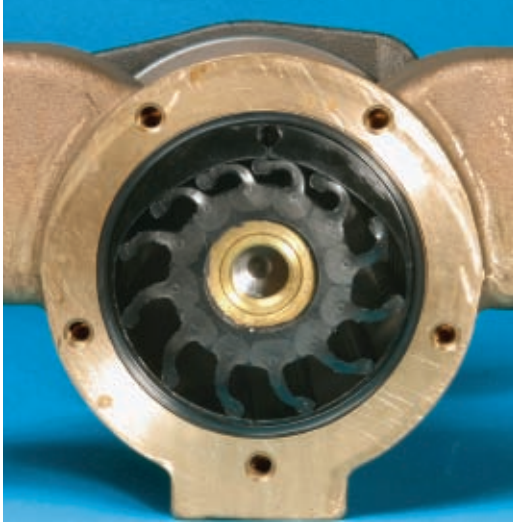
Models: G1808, G18081-01, G1810, G1810-01,
G1814-01, G18082, G1814X, G1811-01 and G1816-01

Vanes flipped to the left
(viewed from cover).
